Watersville M. E. Church Watersville Road

Survey No. CARR-1106

Maryland Historical Trust State Historic Sites Inventory Form

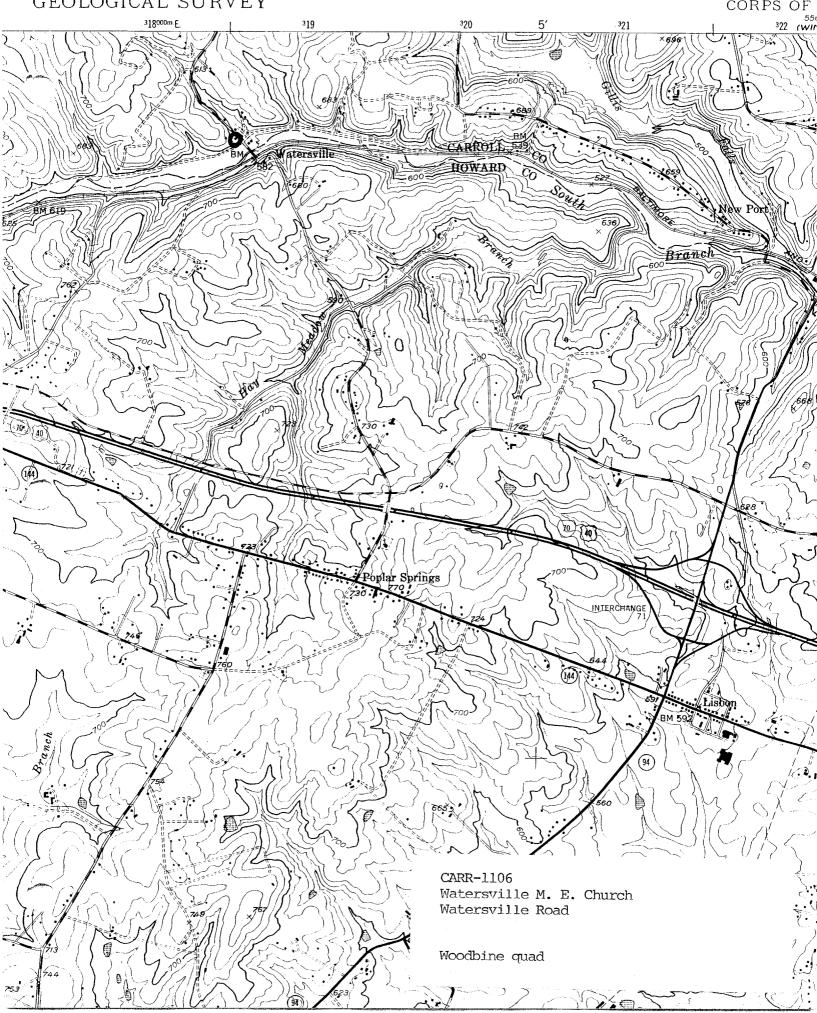
CARR-1106 Watersville M.E. Church Watersville Road Carroll County, Maryland Photo: Kenneth m. Short Date: February 1993 Neg. Loc.: Maryland Historica I Trust south; east elevations 1/1
